# Cavity Fault Analysis Summer 2020 Data Set

Tom Powers  
30 Nov. 2020

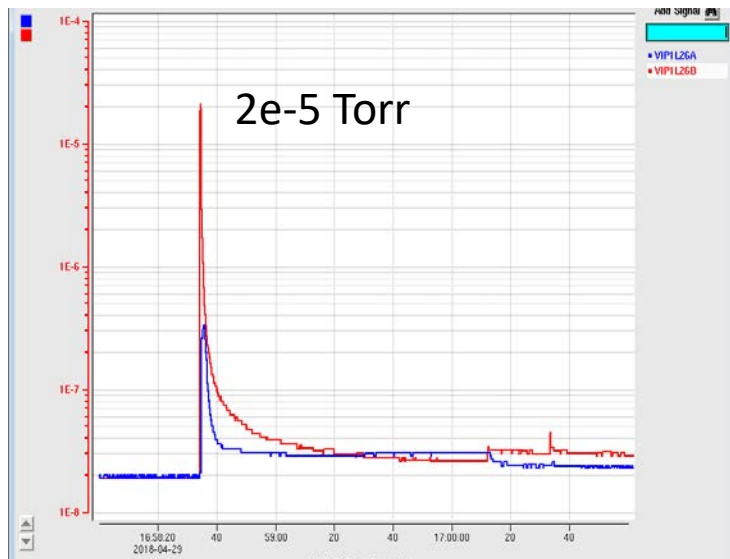
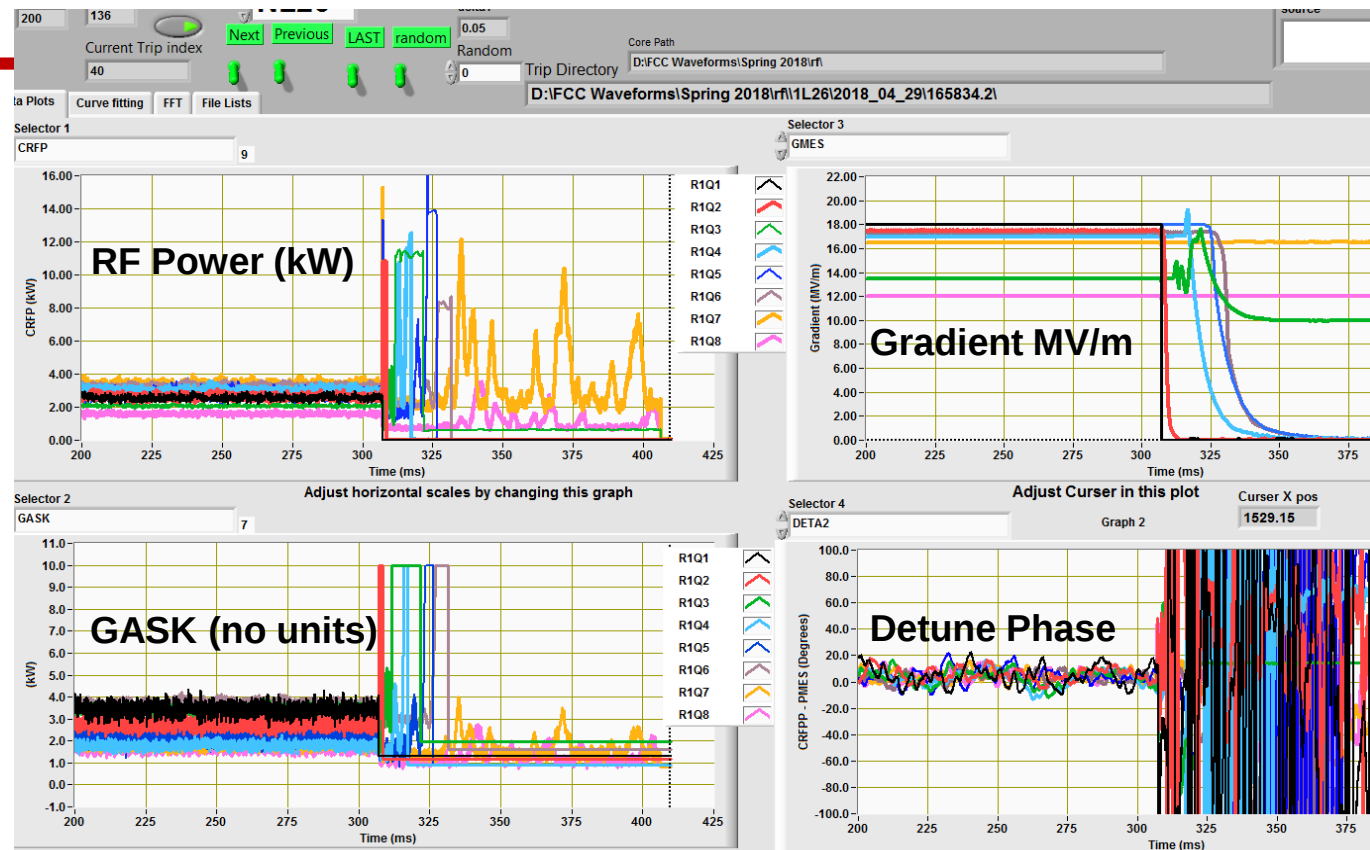
- Fall time of cavity gradient faster than 50 us (one point at this acquisition rate).
- Cavity seemed to be operating normally up until this point.
- **Theory** -- vacuum burst in cavity releases large quantities of electrons which absorb the energy within the cavity.
- 93% of the fast quenches in the Fall 2019 run were in cavities 1 or 8 the rest were distributed between the other 6.
- Extensive leak checking was done without finding a problem. FE radiation induced photo-desorption is likely.

- Corresponding beamline vacuum excursion.
- Red trace is pump next to cavity 1 blue trace is at the upstream end of the girder.
- Peak vacuum signal adjacent to cavity  $2e-5$  Torr at the other end of the girder was  $3e-7$  Torr.
- No events were recorded where cavity 1 in one zone and cavity 8 in the adjacent zone had the same fault at the same time which indicates that the event was not due to a vacuum burst in the girder between the cryomodules.

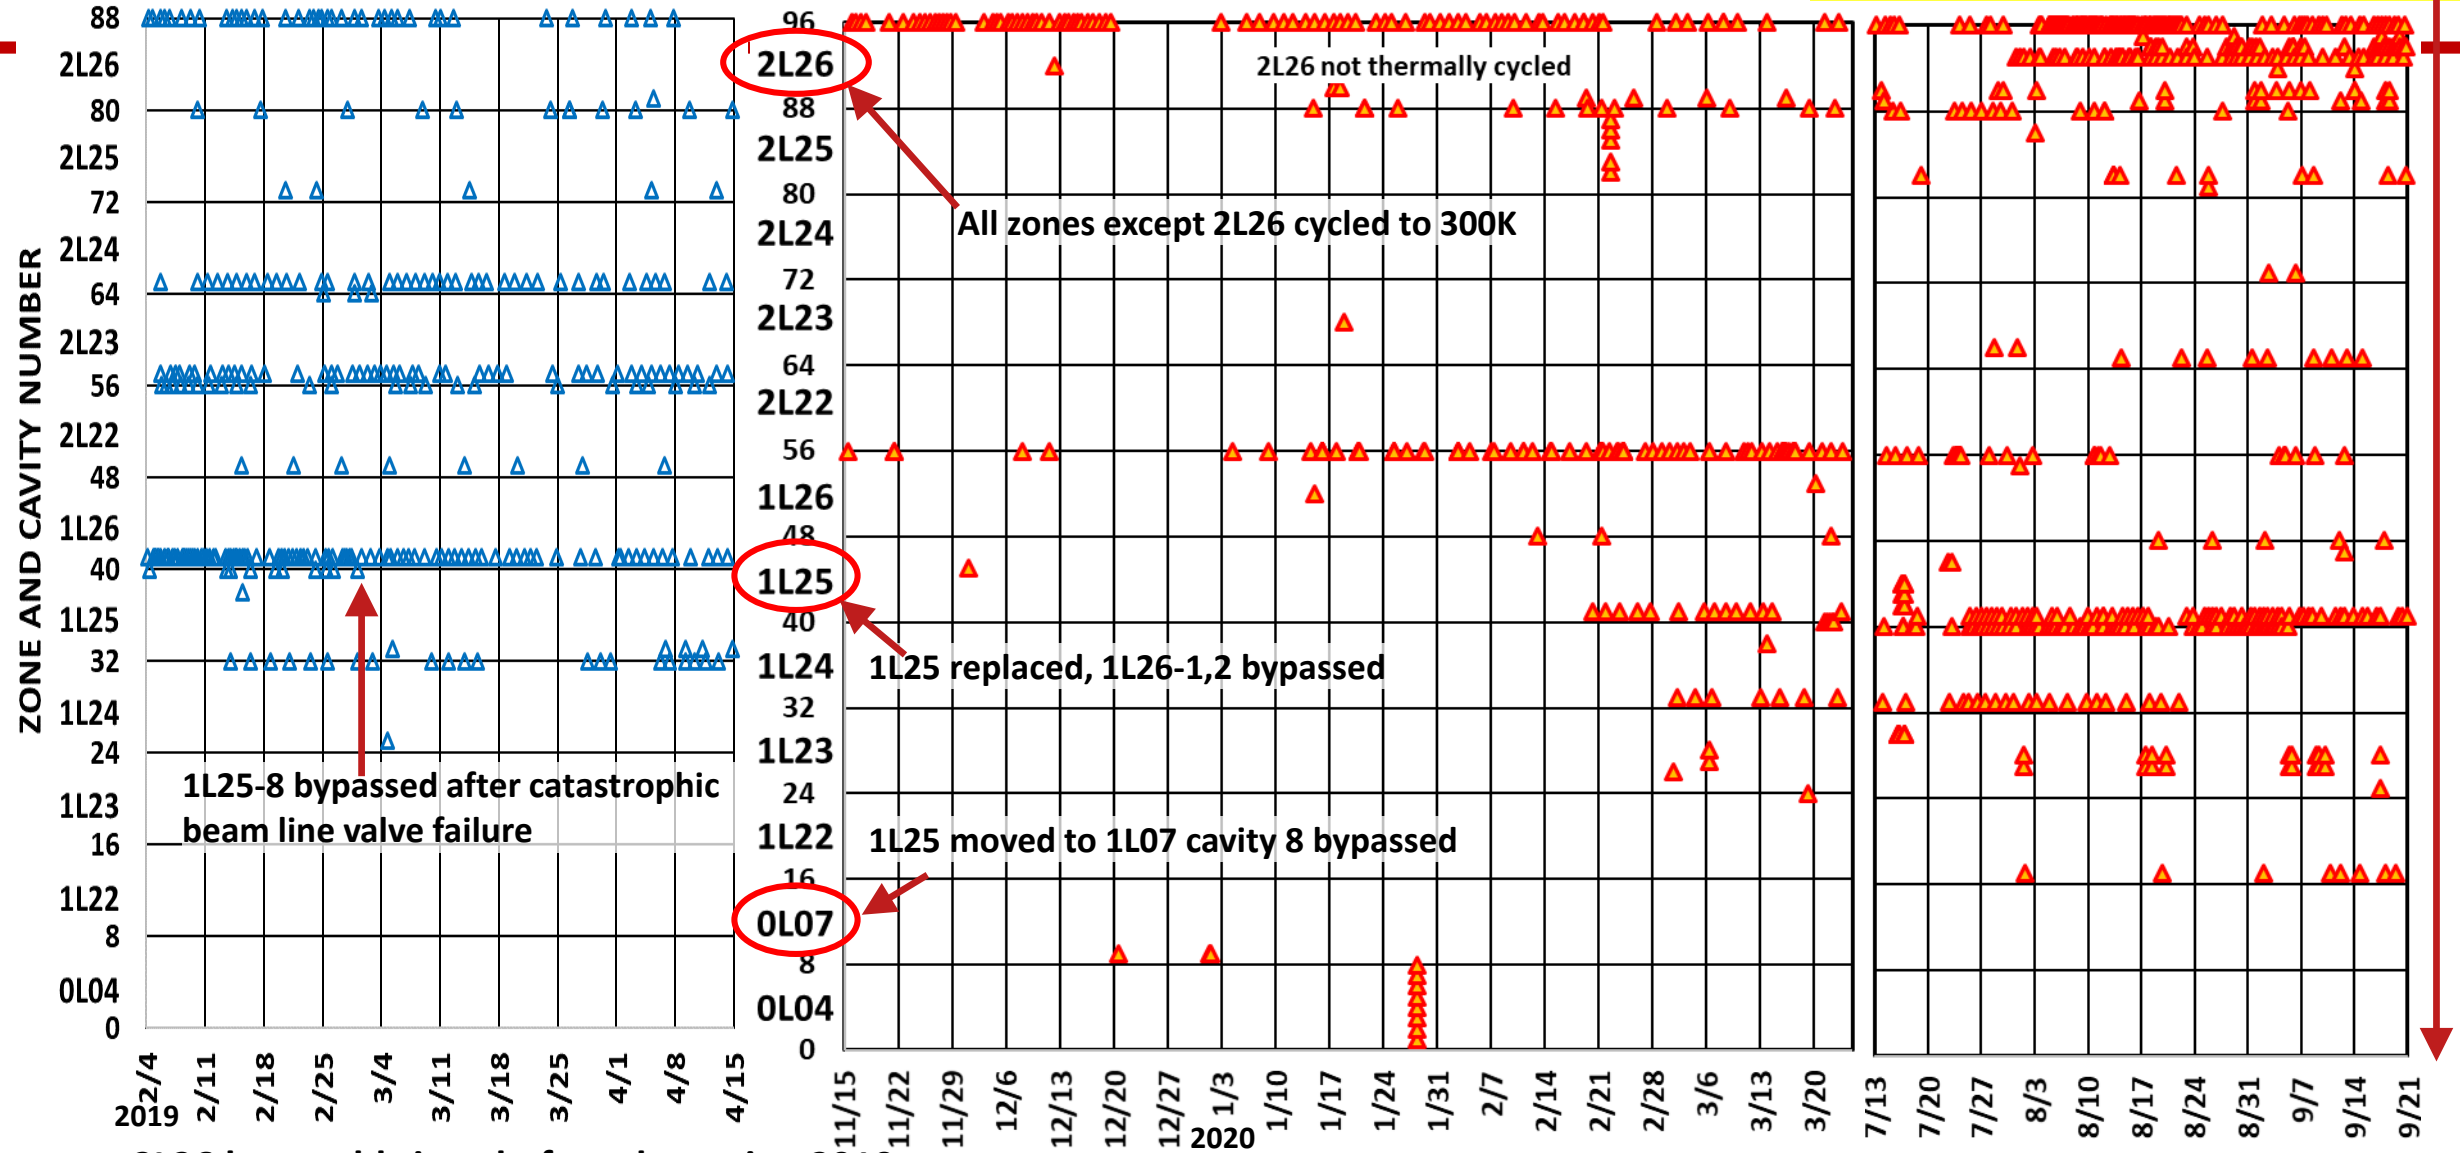
North Linac being thermally cycled to 300K  
2L26 will be cycled to 300K

- 2L26 kept cold since before the spring 2019 run
- All other cavities warmed up to 300K and girders were pumped on for 2 or 3 months, 1L26 was warm for 5 weeks.

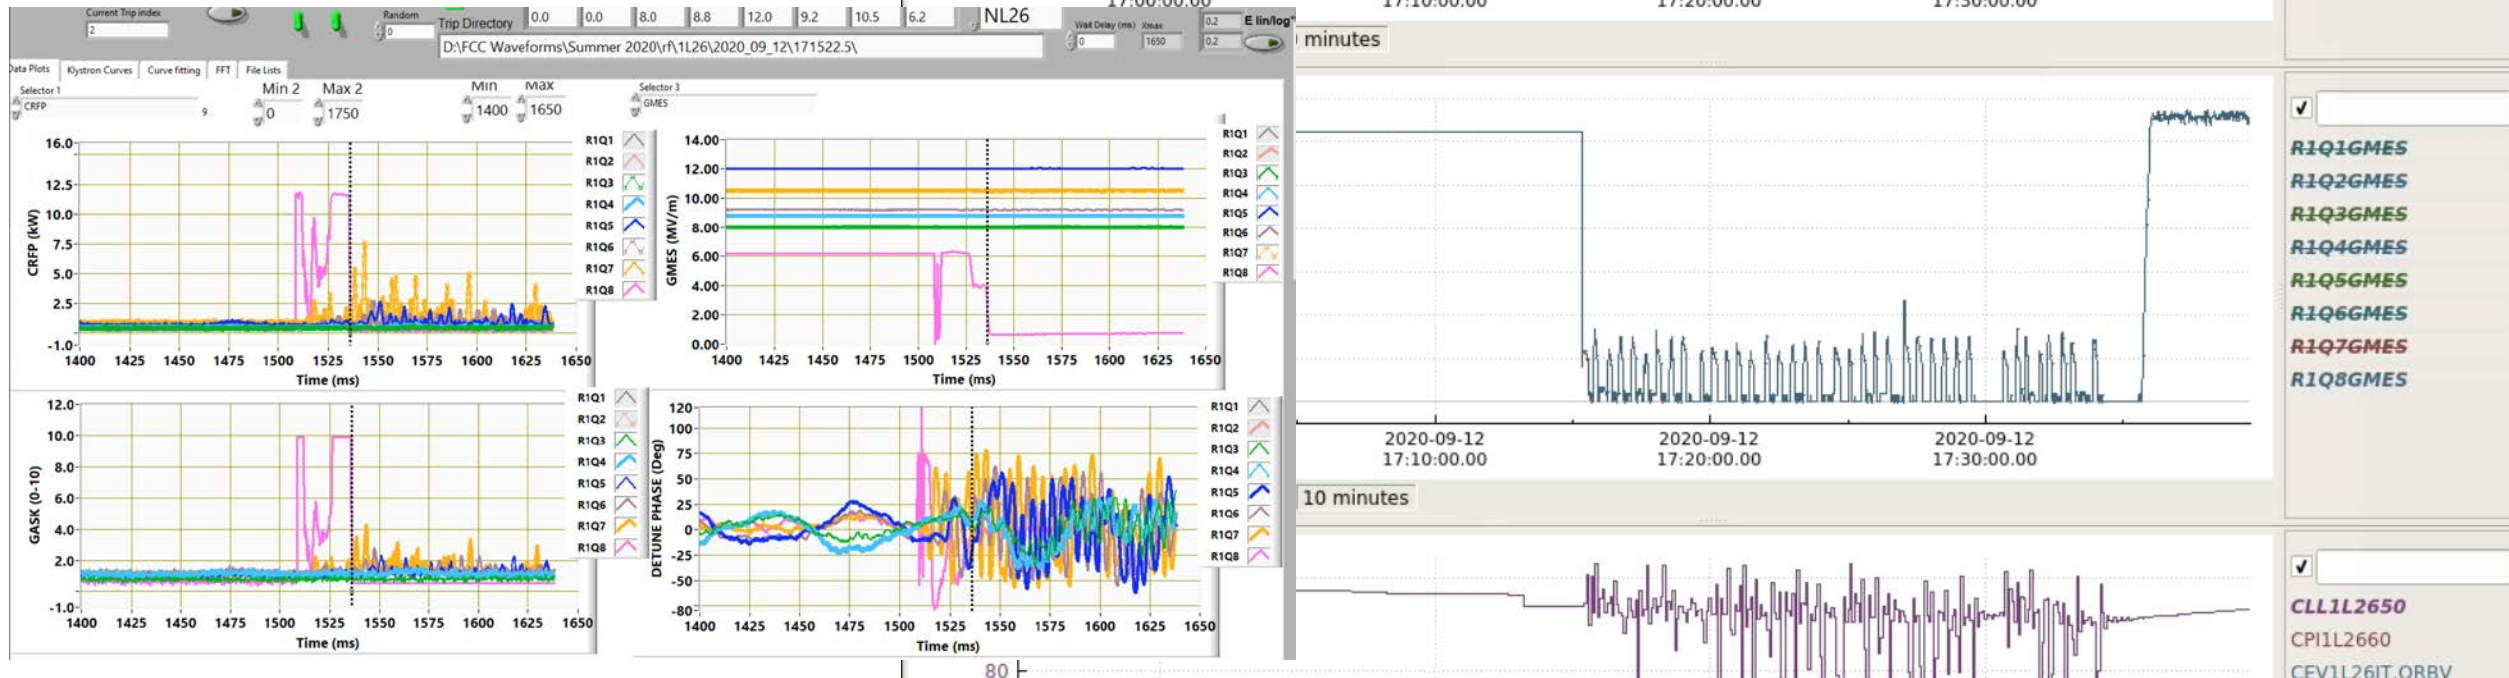
- On a few zones cavity 1 or 8 would have repeated thermal quenches
- In this instance it took about 20 minutes for the zone to recover.

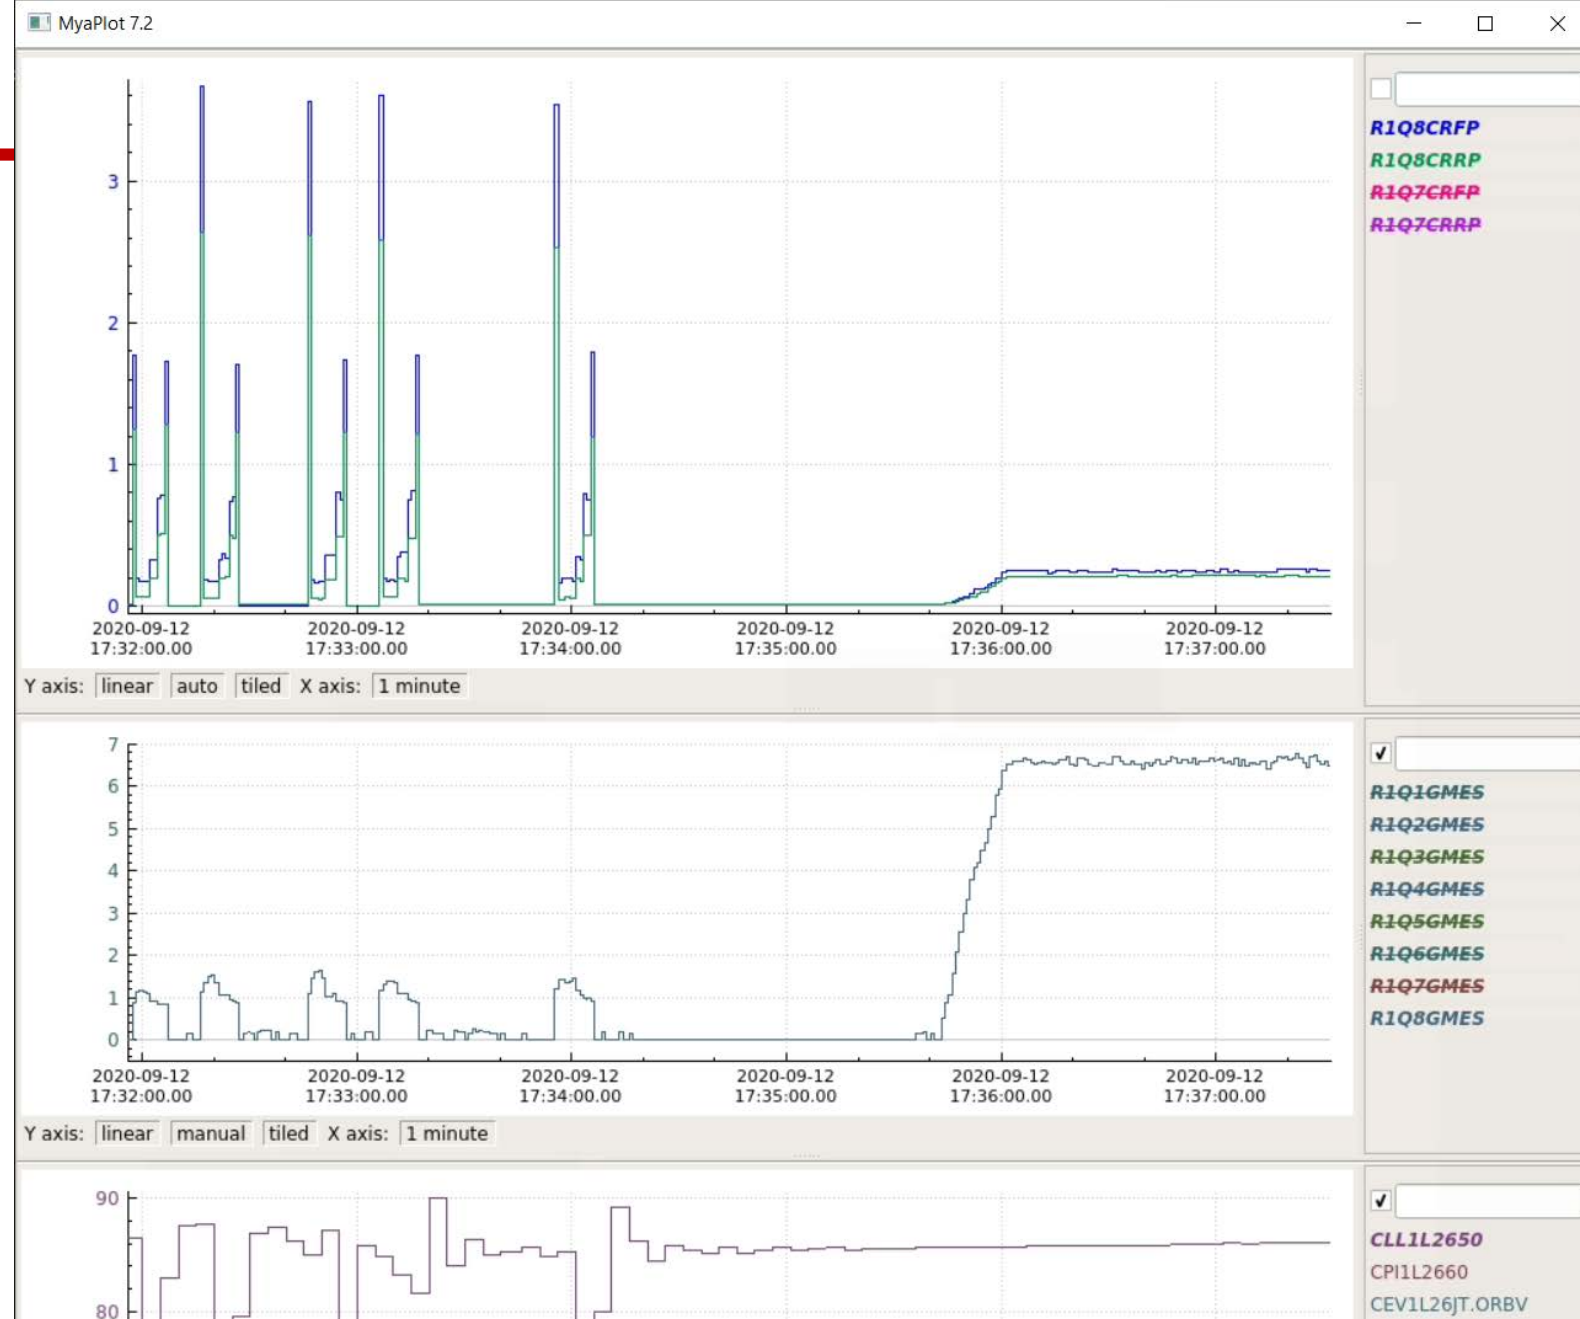
- The system tries to ramp the gradient up to 6.5 MV/m and has substantial RF power 500W to 1 kW dissipated in the bath.
- The system finally recovered after the cavity was left off for about 1.5 minutes.
- Observation - Cavities 1 and 8 have different boundary conditions where the beam pipe on the HOM end is attached to the warm to cold transition.
- On other cavities the HOM beam pipe is connected to a cavity at 2K.
- Similar events were observed in 2L26 and 1L23.
- Somehow this type of event needs to be flagged and a delay before turn on should be applied.

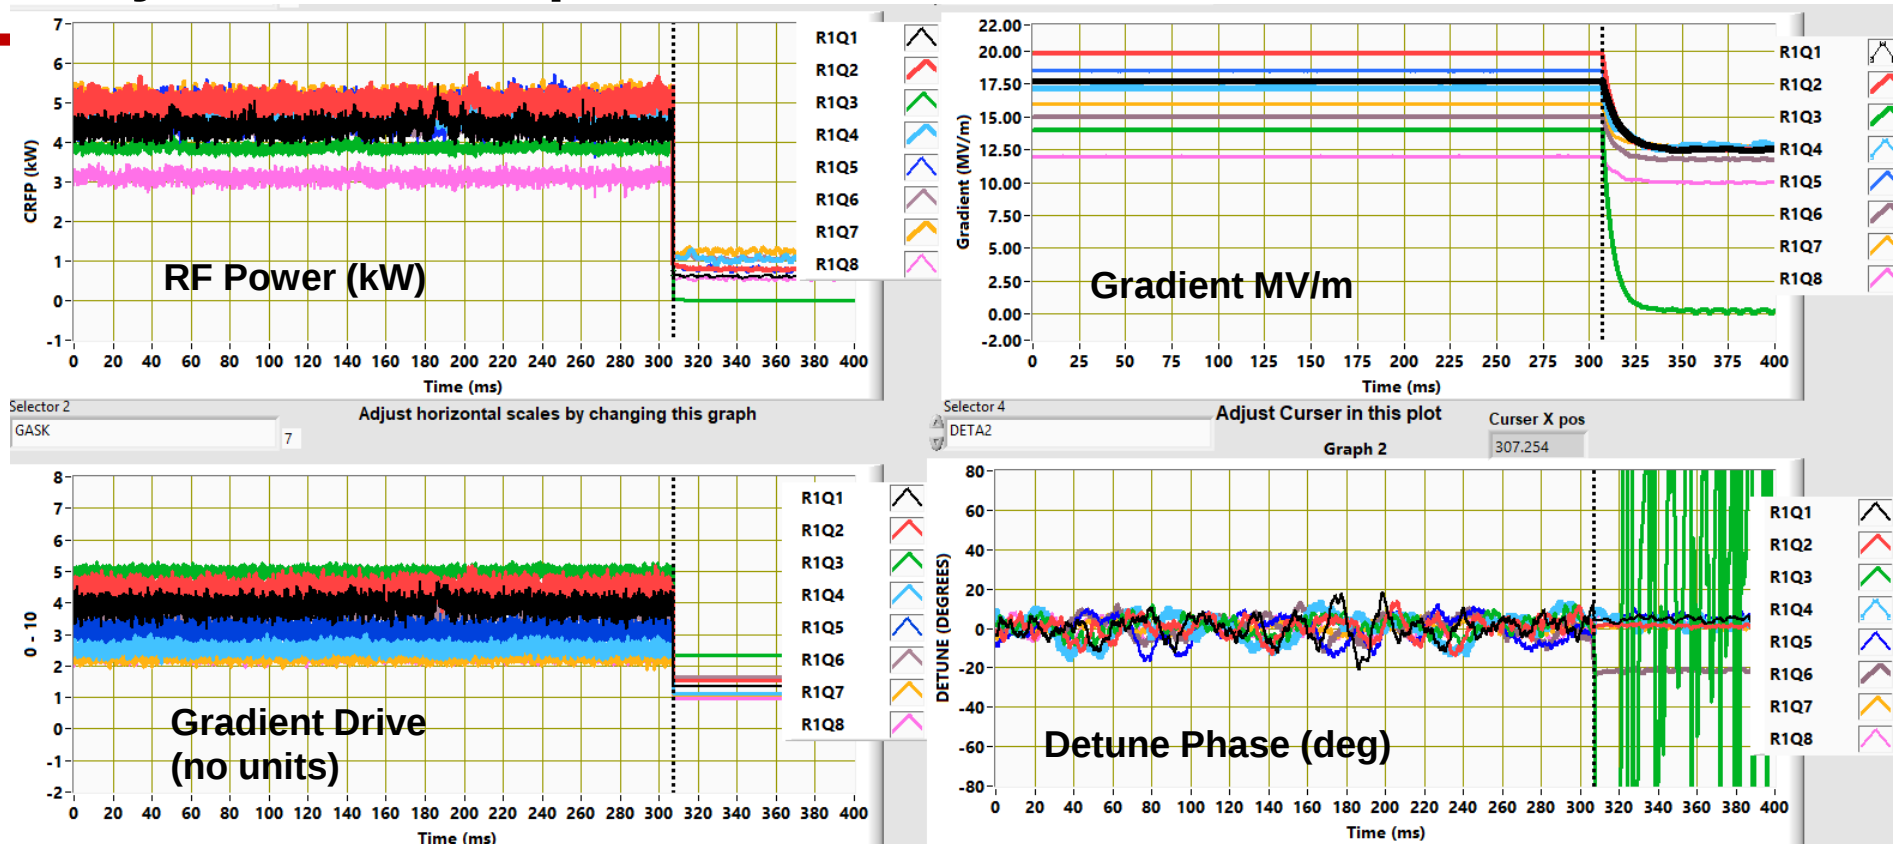
- Zone running fine and at about 300 ms cavity 3 trips off going to a zero RF power even while GASK is not at zero. This is an indication that the RF switch was open.
- The gradient decays with a nominal turn off decay time.
- Note that the forward power did not jump up before the fault.
- Detailed analysis of the archived fault data indicated that >60% of these faults are quench faults (QNCH) detected by the field control chassis.
- This fault is supposed to be triggered by a 15% reduction in gradient for several milliseconds.

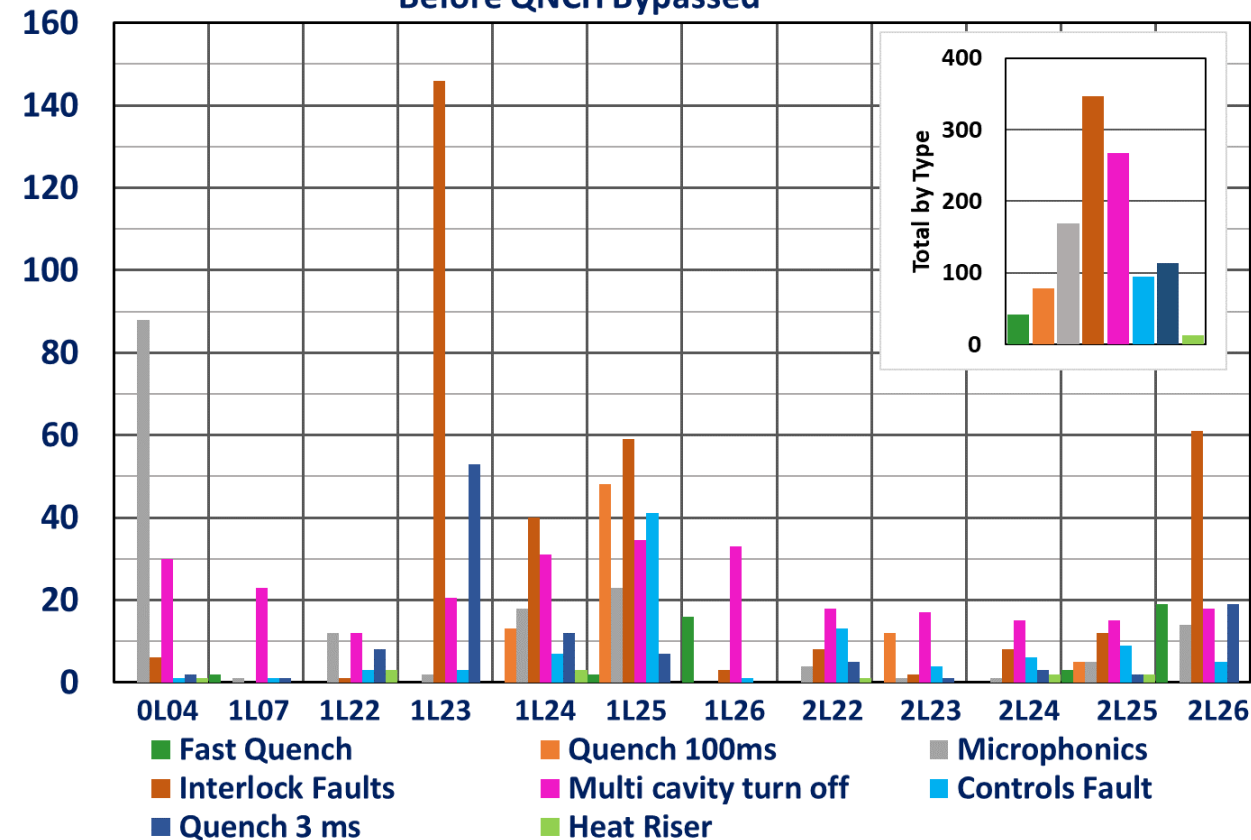
Faults By Zone, N=854, T = 41 Days\* 1Jan to 12Feb  
Before QNCH Bypassed

41 days prior to bypassing QNCH faults, 40% of faults were interlock faults

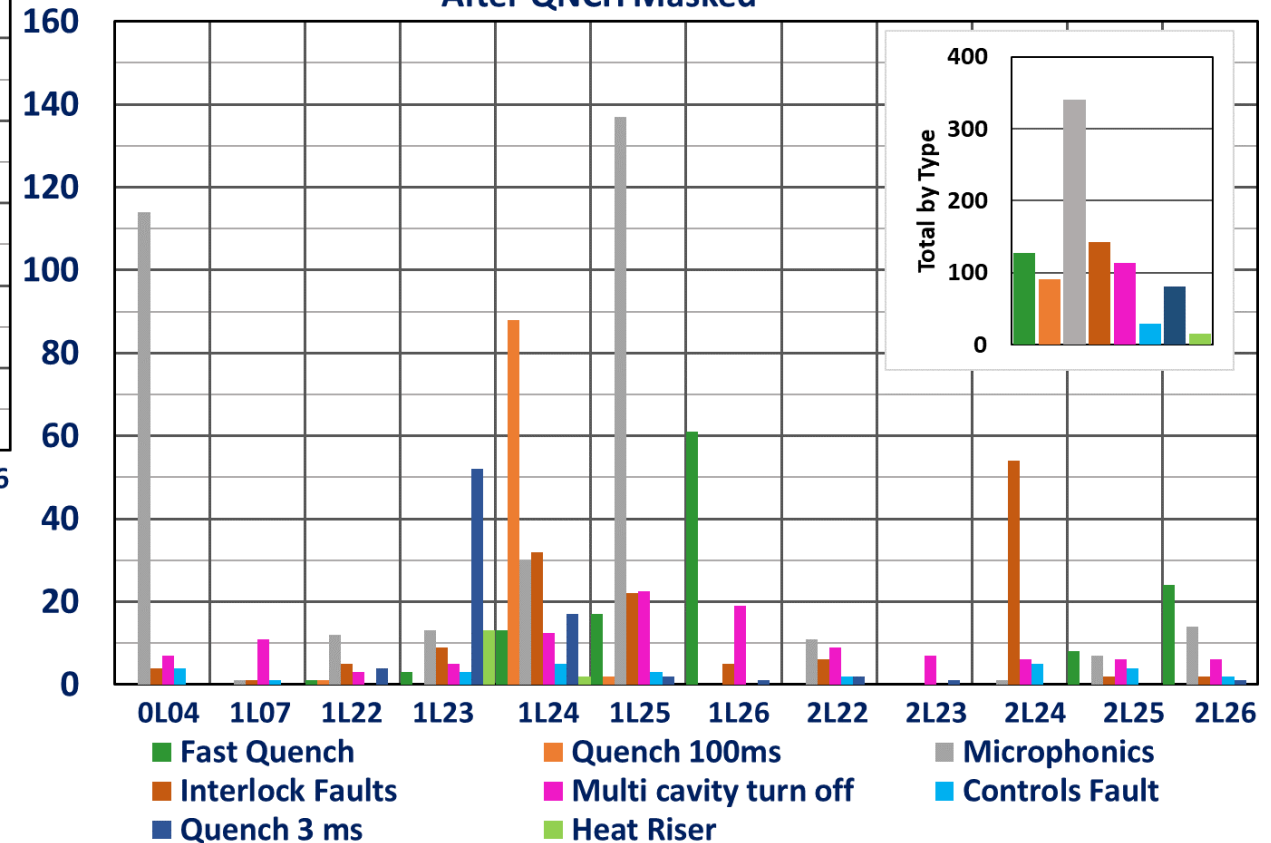
Faults By Zone, N=824, T = 41 Days\* 12Feb to 24Mar  
After QNCH Masked

- Most of the faults were Microphonics, or in 1L25 arcs or vacuum faults induced by Microphonics.
- 15% were interlock faults

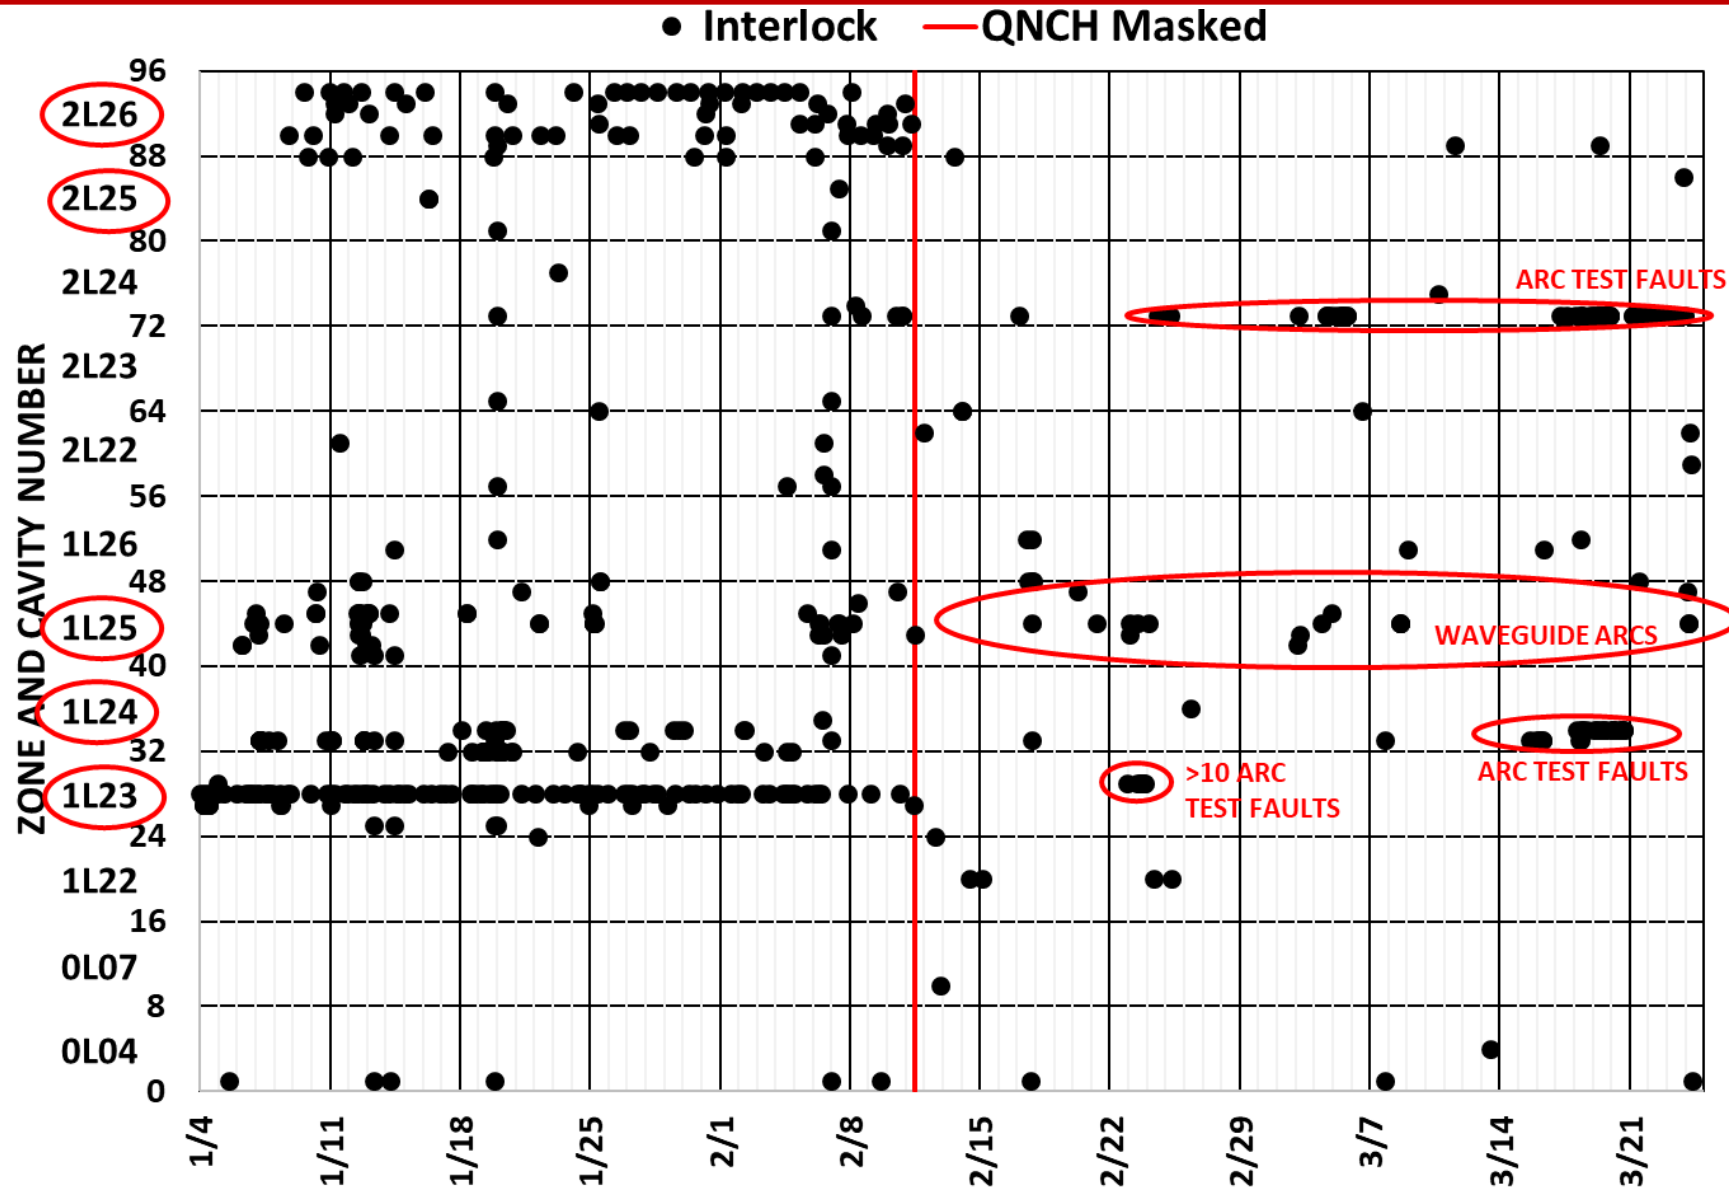
After 5 zones had the QNCH fault bypassed.

- Of the 129 faults identified as interlock faults
- 70% were arc test faults
- 18% were arc or waveguide vacuum faults
- 10% were QNCH faults on zones where it was not bypassed
- 4% were gradient or phase error faults

The QNCH faults were on zones that were not bypassed.

Gradient error faults is the interlock that replaced the functionality of the QNCH fault.

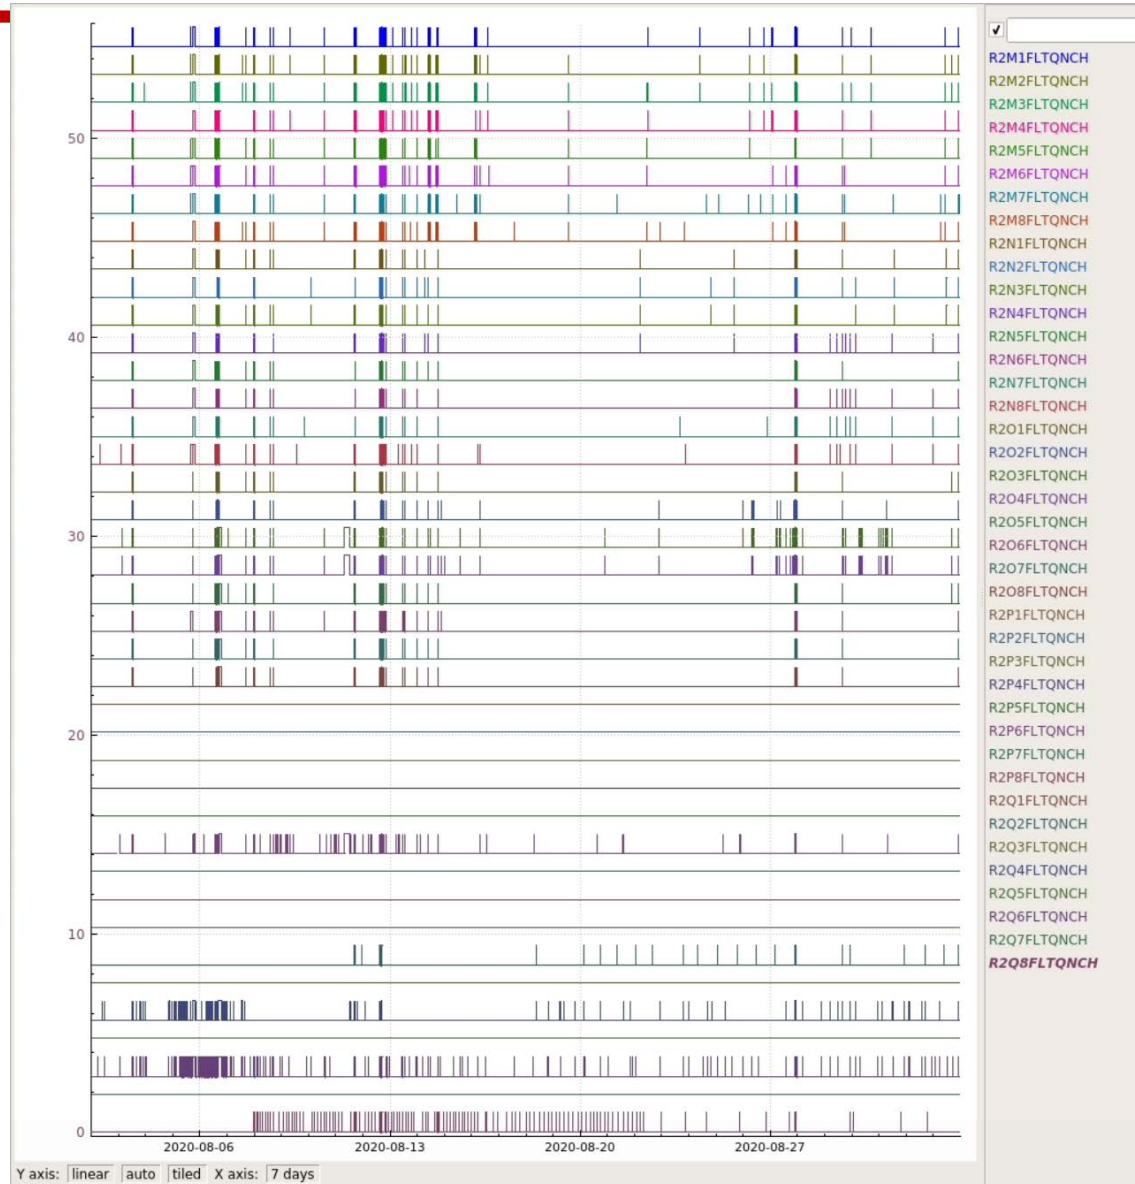
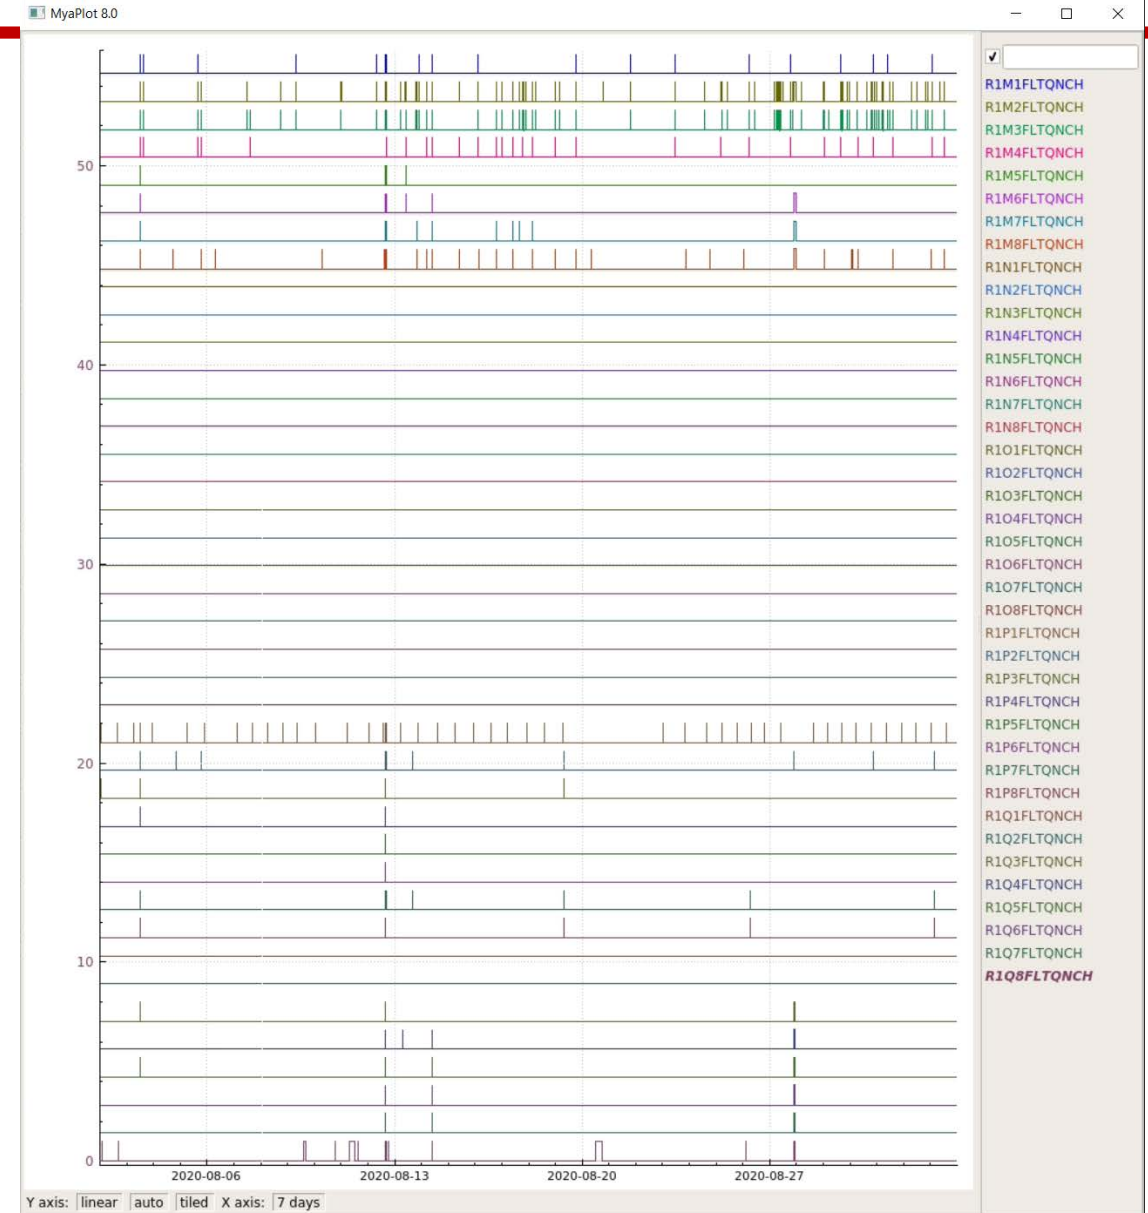
# Quench Fault Still Occurring Repeatedly Even in Zones Where it was Bypassed

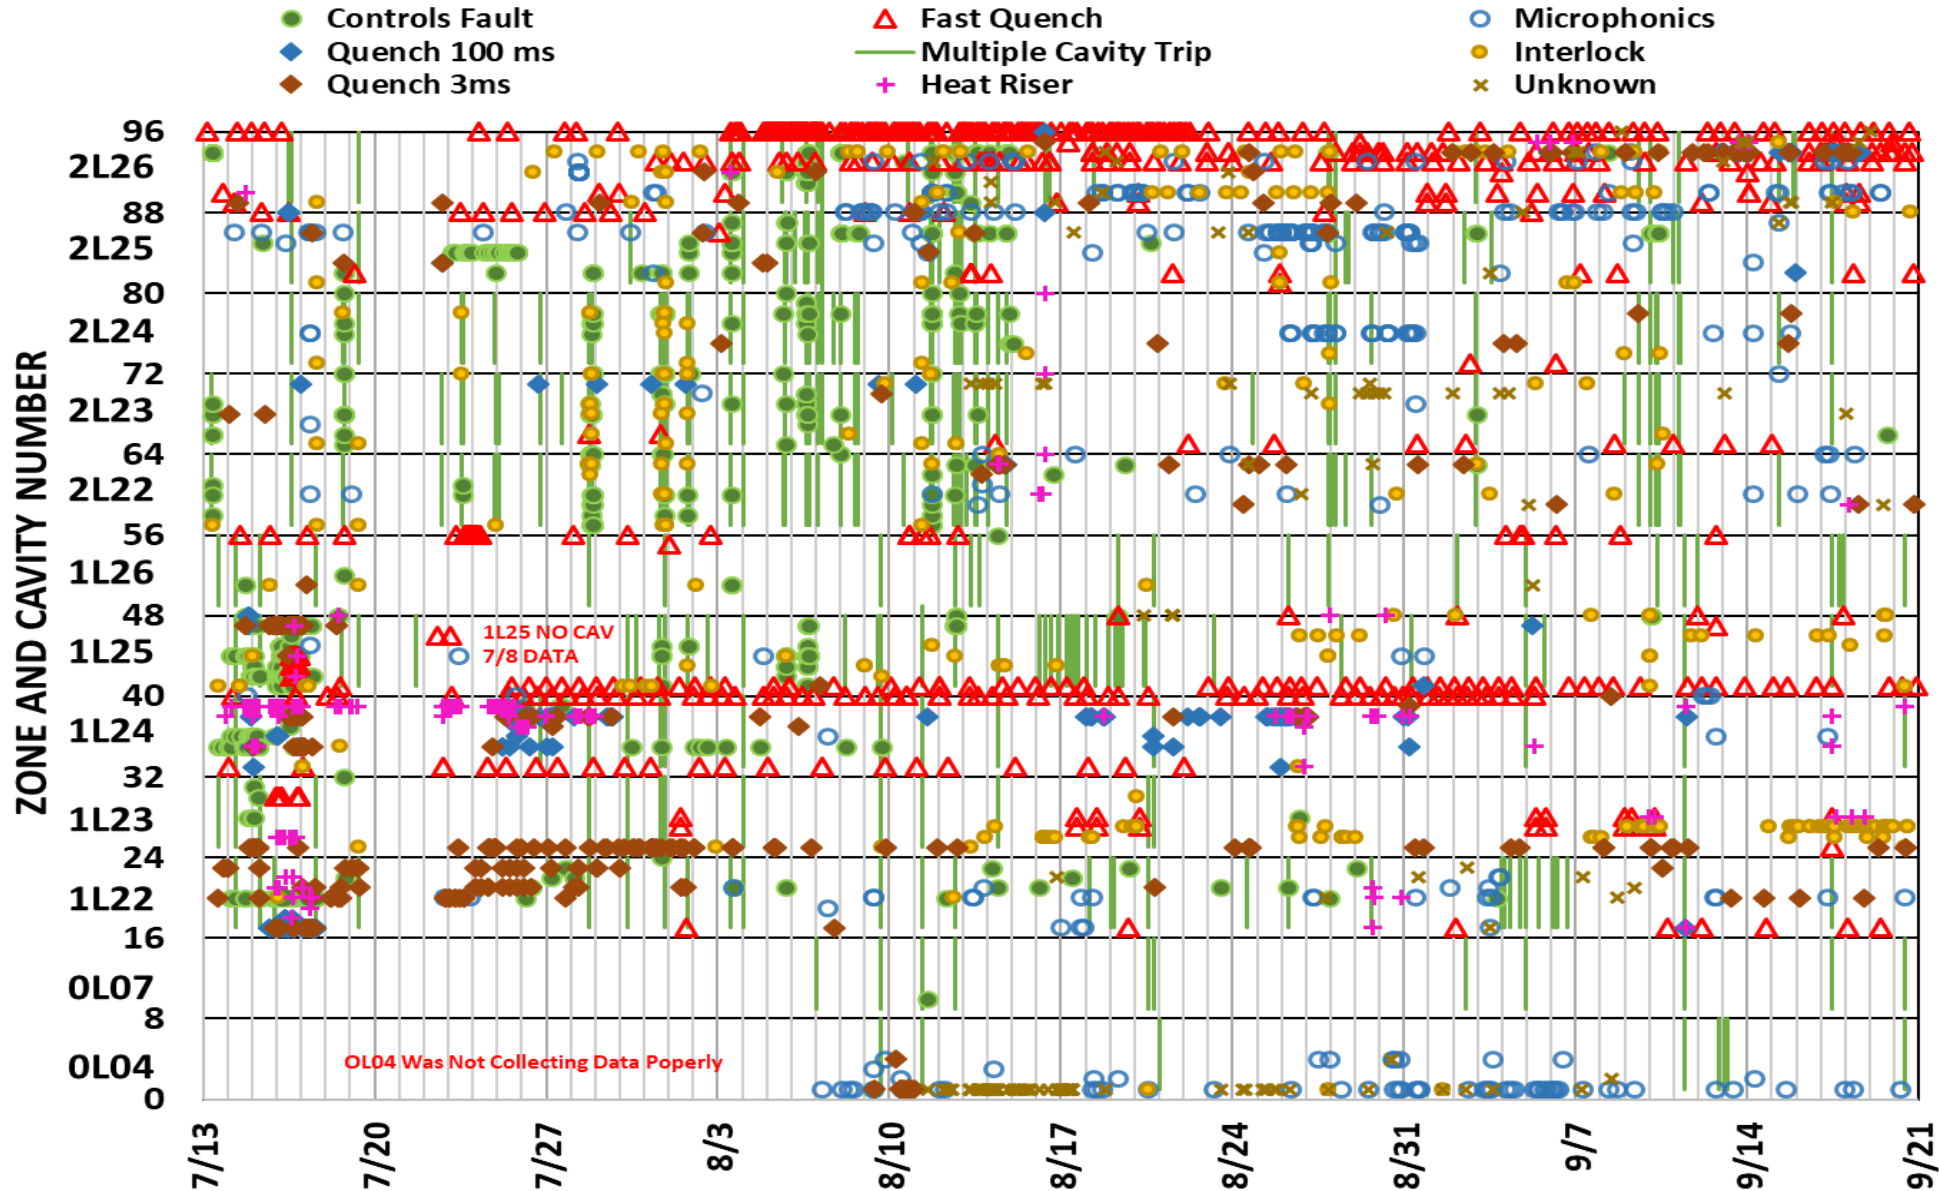
Starting in early August, 2L26 got worse even after we reduced gradients.

Multiple cavity trip events and controls faults occurring in multiple zones due to noise in the MO system. Indicated by Green vertical lines and green circular symbols.

1L25 Microphonics mitigations installed before run improved things.

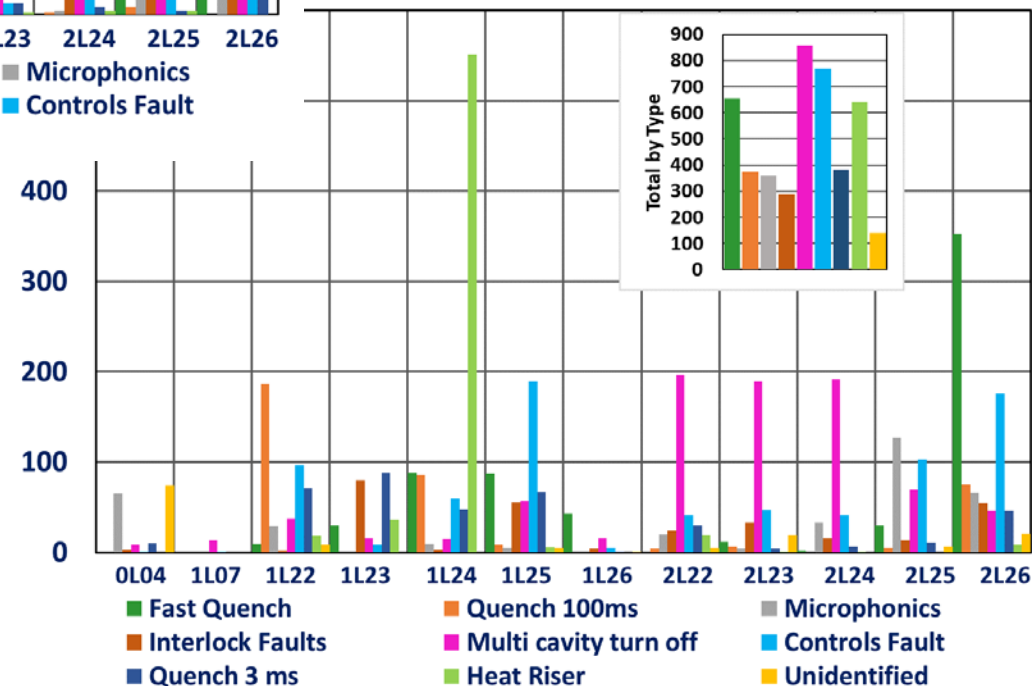
N=4405, T = 71 Days\* 14 Jul 20 to 21Sept20

- Summer 2020
- Microphonics mitigations applied to 0L04, 1L25 and 1L24, 2L25 and 2L26.
- QNCH fault bypassed in the 5 worst zones. Reduced interlock faults but some came back?
- Approximately 1000 faults are due to the MO noise issue. (controls and multi cavity faults)
- The excessive number of heat riser faults was due to a pressure oscillation in cryogenic plant which was corrected 3 weeks into the run.
