# Cavity Fault Analysis Summer 2020 Data Set

Tom Powers  
30 Nov. 2020

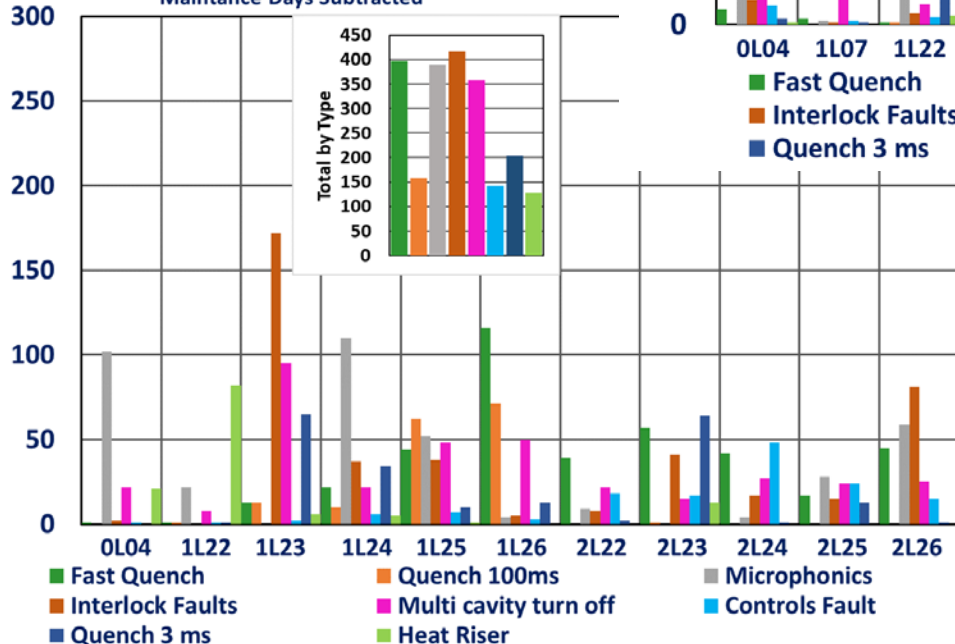
N=2182, T = 79\* Days 18 Jan to 15 Apr 2019

- Additional microphonics mitigations applied to 1L24, 2L25 and 2L26
- C100 cryomodules except for 2L26 thermally cycled to 300K
